THE CONDITION OF PUBLIC BATHROOMS IN THE NEW YORK CITY SUBWAY SYSTEM COULD BE IMPROVED

Daniel G. Cort
MTA Inspector General
State of New York

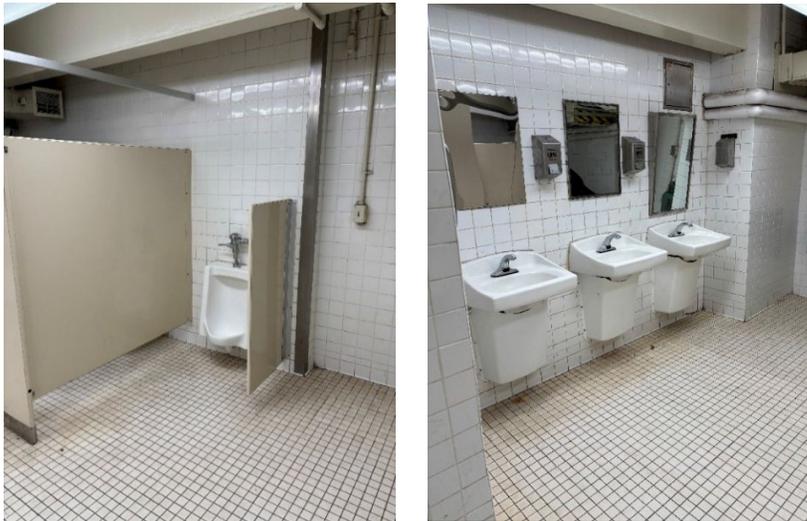
OIG found that all 27 bathrooms that were open were generally in working order: available for use and reasonably clean. The plumbing for at least one toilet in each bathroom was operating well. Further, most of the bathroom stalls had working locks. In some cases, one of multiple stalls had a broken lock. OIG deemed the bathroom open and available for use if it contained at least one stall with a working lock. In a positive finding, OIG observed that the bathrooms were mostly clean and functional. (*See Photos #1 and #2.*)

Photos #1 and #2:
The clean and
fully functional
men's bathroom
at the 14th Street
Station on the
A/C line.

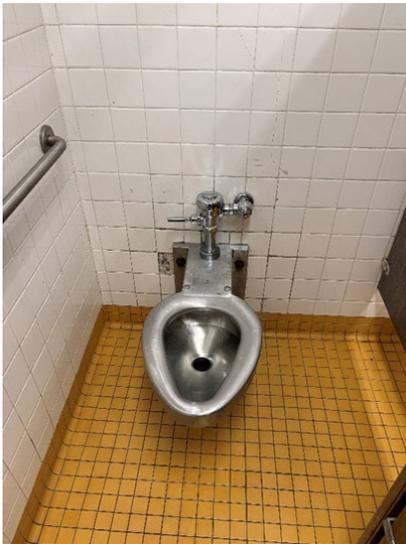
Of the 37 toilets OIG observed, 10 were made of stainless steel and lacked a toilet seat. (See Photo #3, below.) These toilets were in the men's and women's bathrooms at 125 Street (4/5/6 lines), 161 Street (4/B/D lines), Jackson Heights-Roosevelt Avenue (E/F/M/R lines), Jamaica 179th Street (F line), and the men's bathroom at Forest Hills (E/F/M/R lines). Each of these 10 toilets had two capped bolt assembly holes where a seat could be attached.

Photo #3 (left): A stainless-steel toilet without a seat in the women's bathroom at 161st Street on the 4 line.

NYC Transit officials gave varying explanations as to why some toilets did not have seats. One common response was that the seats had been removed to reduce vandalism. While this may be the case, OIG found no evidence of toilet seat vandalism at the locations that currently have stainless-steel toilets. In reviewing the EAM database and additional data provided by Facilities, OIG could not find documentation of repeated toilet repairs, vandalism, or replacements at those locations. A Facilities official also told OIG that the type of toilet installed in bathrooms is based on availability; that is, the agency will install any type of toilet that it has in inventory.

3. NYC Transit Facilities should ensure that the default design standard for newly installed or replaced toilets includes a seat.

4. NYC Transit Facilities should install seats on existing toilets that lack them wherever feasible, meaning locations that do not require extensive/expensive retrofitting.

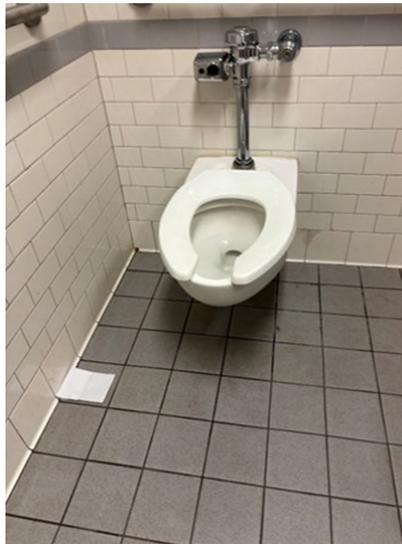
Photo #4 (right): A porcelain toilet with a seat in the women's bathroom at Hudson Yards on the 7 line.

NYC Transit has installed different types of equipment in its public bathrooms throughout the system. Notably, Hudson Yards, with the newest bathrooms, has porcelain toilets and seats, which adhere to current plumbing codes. (See Photo #4, above.) Ultimately, OIG could not determine why, or for what period, NYC Transit chose to install stainless-steel toilets, and why those toilets in our sample did not have seats installed.

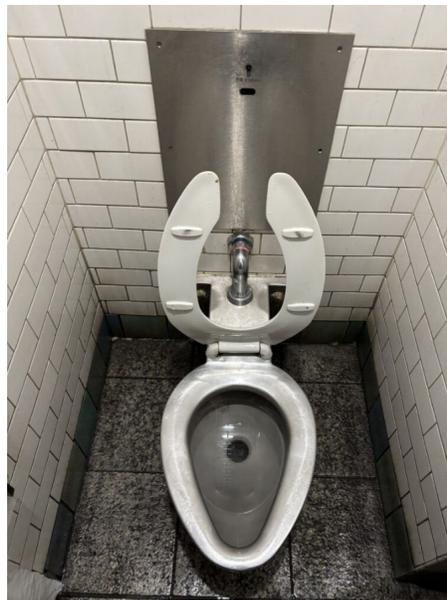
Installing seats on the small percentage of toilets that currently lack them would require minimal cost and effort and would improve hygiene and customer satisfaction. In one privately maintained bathroom at Times Square-42 Street Station, OIG observed hardware on the stainless-steel toilets that would easily allow toilet seats to be installed, as shown in Photo #5 below. This demonstrates that it is possible to affix a toilet seat to a stainless-steel toilet.¹²

Photo #5: A stainless-steel toilet with a plastic seat affixed to it in a unisex bathroom.
